**MARINE BORERS AND THEIR RELATION TO
MARINE CONSTRUCTION ON THE
PACIFIC COAST**

**FINAL REPORT
OF THE
SAN FRANCISCO BAY MARINE PILING COMMITTEE**

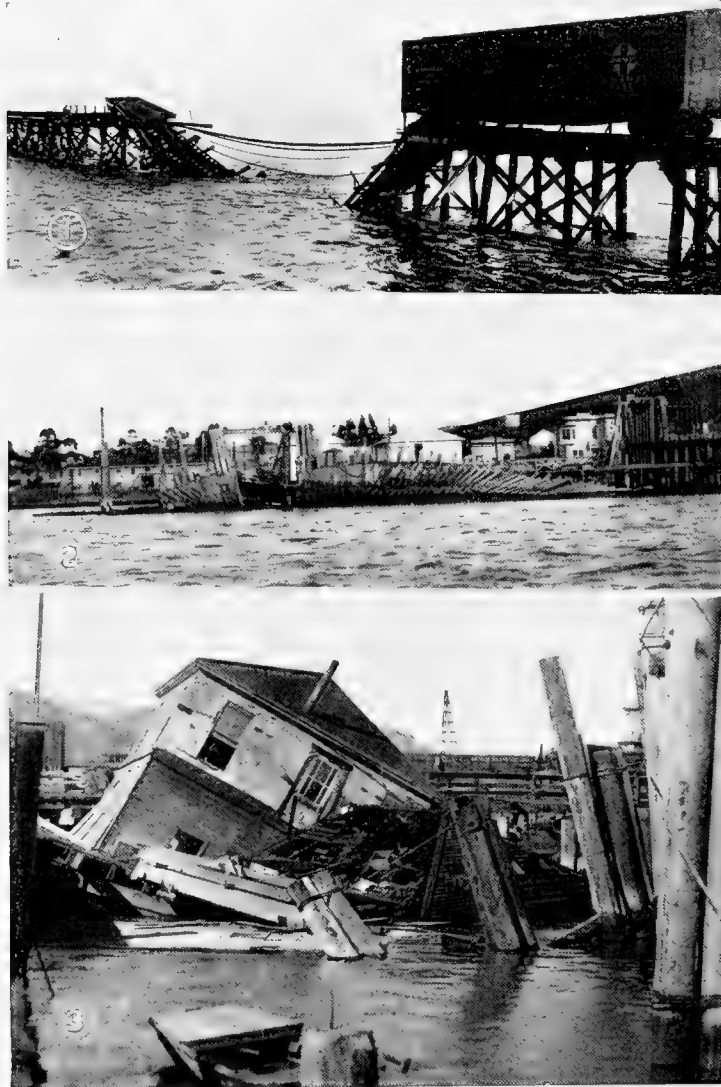
Fig. 1. Dock failures in Carquinez Strait.

- (1) One of the first docks which failed. Oleum, California, Oct. 8th, 1919. Several loaded freight cars were plunged into the bay.
- (2) Ferry slip at South Vallejo, failed November 4th, 1920.
- (3) Municipal Wharf and house, Benicia, California. Collapsed Oct. 7th, 1920.

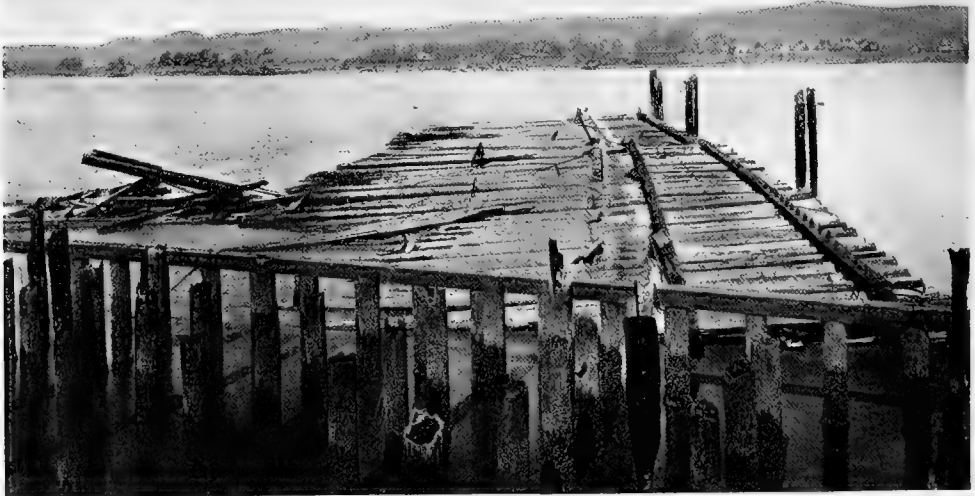
Fig. 12. Untreated ferry slip fender piles in Carquinez Strait destroyed by teredo, 1919.
(S. P. Co. Photo.)

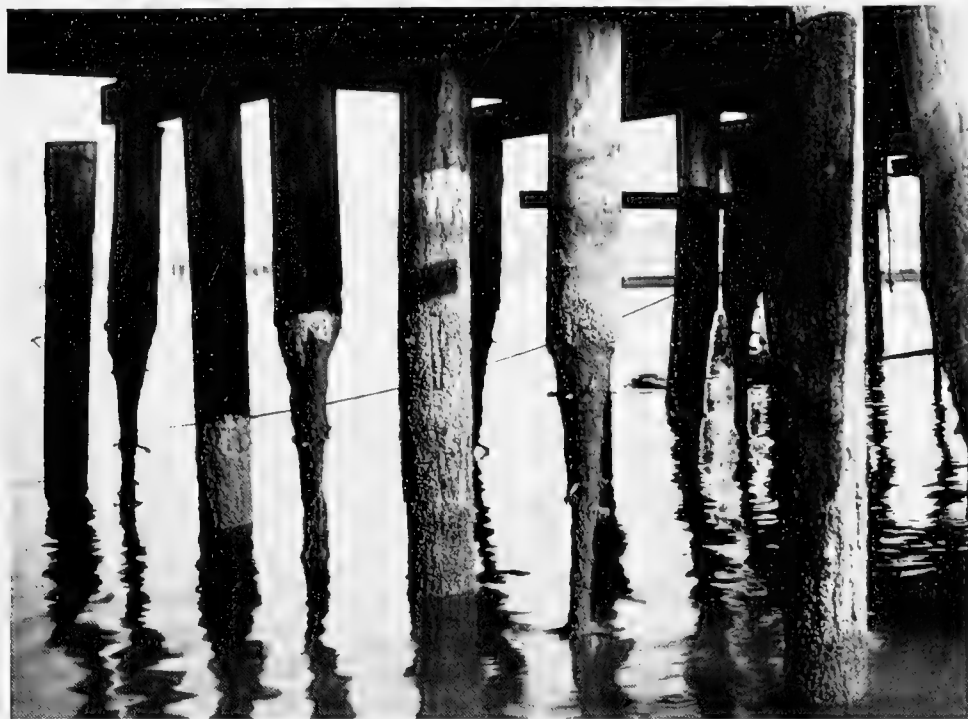
Fig. 13. Untreated Douglas fir piling in Oakland Estuary, destroyed by *Limnoria*. Good piles shown are replacements. (Moore Shipbuilding Co. Photo.)

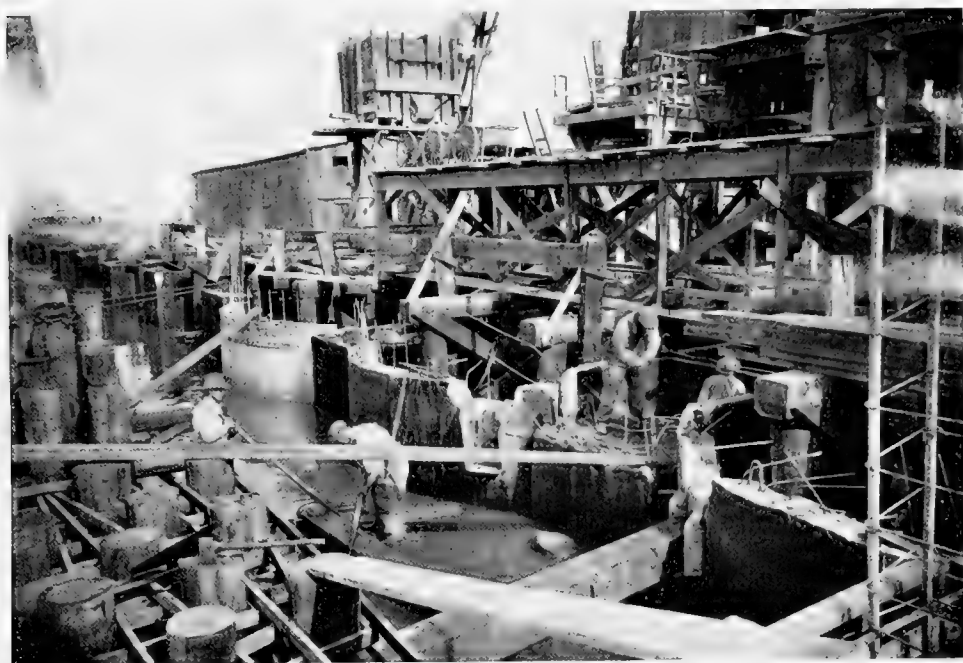
Fig. 15. China Basin terminal during construction, showing caissons after filling (workman whose hands are blurred is standing in one) and pre-cast curved arch slabs in place.
(Board of State Harbor Coms. Photo.)

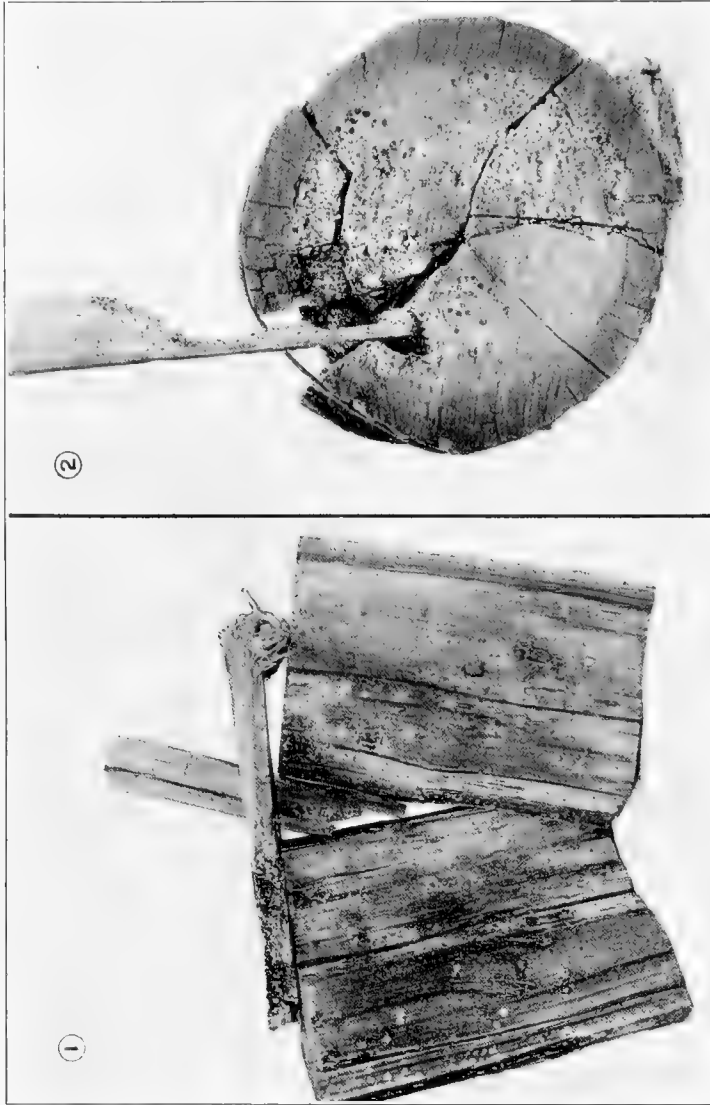
Fig. 25. (1) Vertical section, and (2) cross-section through portion of a perfectly treated pile which was split and broomed during driving. *Teredo* entered splits and worked through untreated heartwood to the creosoted outer shell, which was attacked in a few spots as shown by smaller pieces.

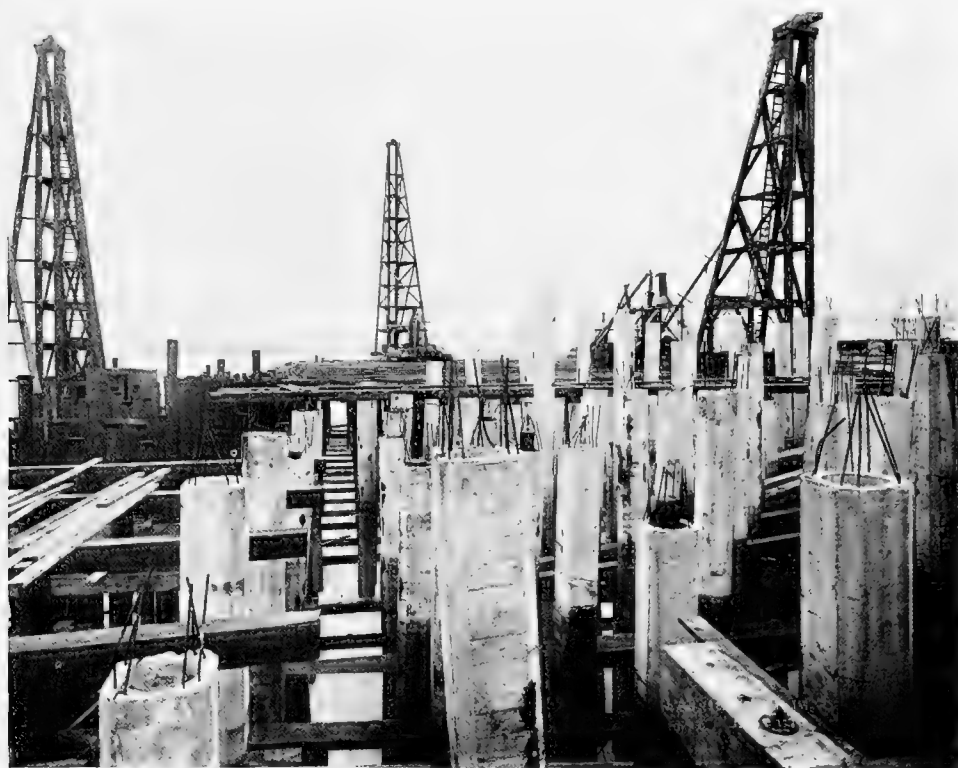
Fig. 47. Pre-cast concrete jackets in place over piles. Alaska Packers' Assn., Alameda.

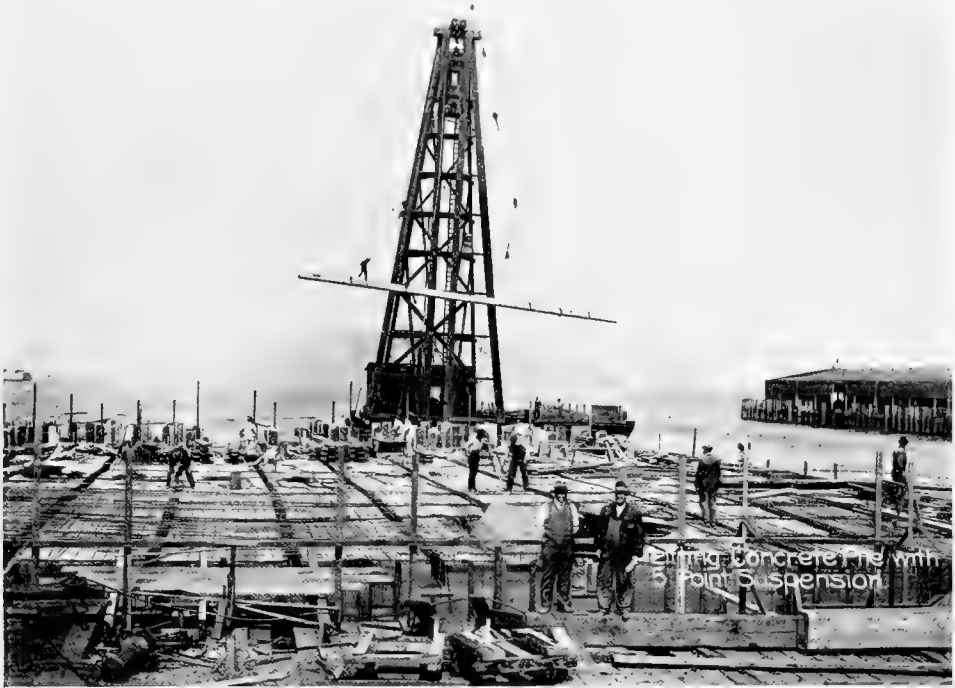
Fig. 51. Handling 105-foot concrete pile with 5-point suspension, Pier 3, San Francisco.
(Board of State Harbor Com's. Photo.)

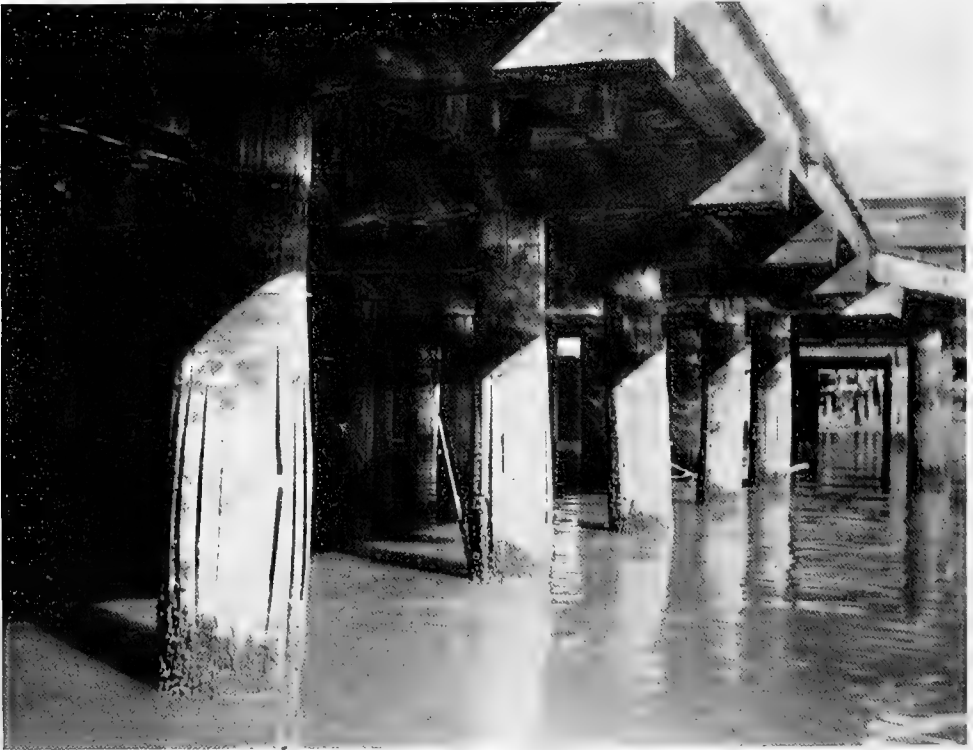
Fig. 56. Piling treated by Moran process, exposed 2 years at Georgia St. Wharf, Vallejo. Note bulging and broken battens. (S. P. Co. Photo.)

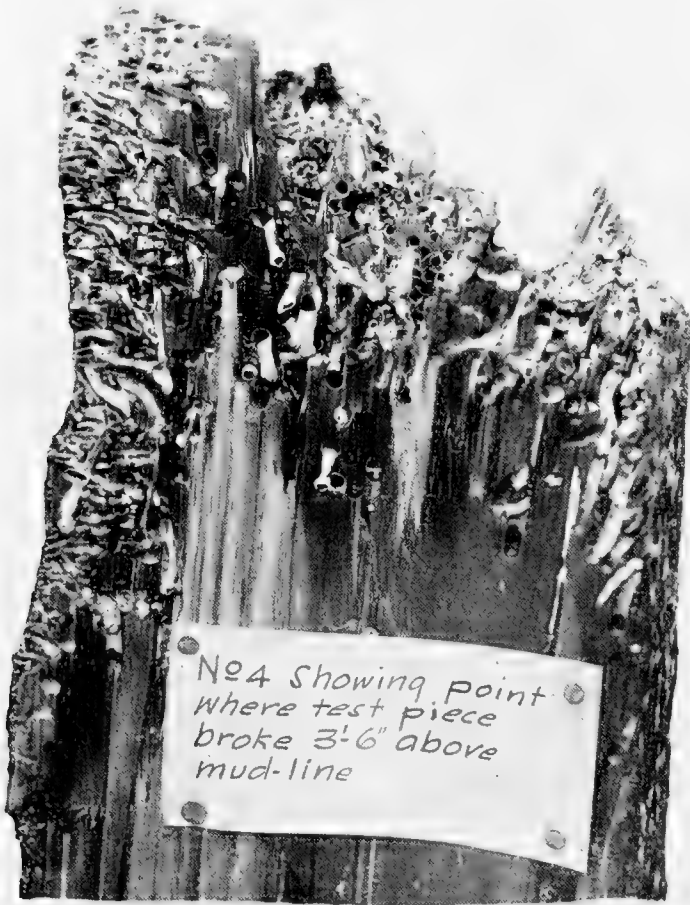
Fig. 87. Breaking point of a 6 x 8 Douglas fir timber planted at Southern Pacific wharf, Port Costa, California, July 1, 1920. First larvae detected at this locality on August 4. Timber removed December 8, 1920. Destroyed by *Teredo navalis*.

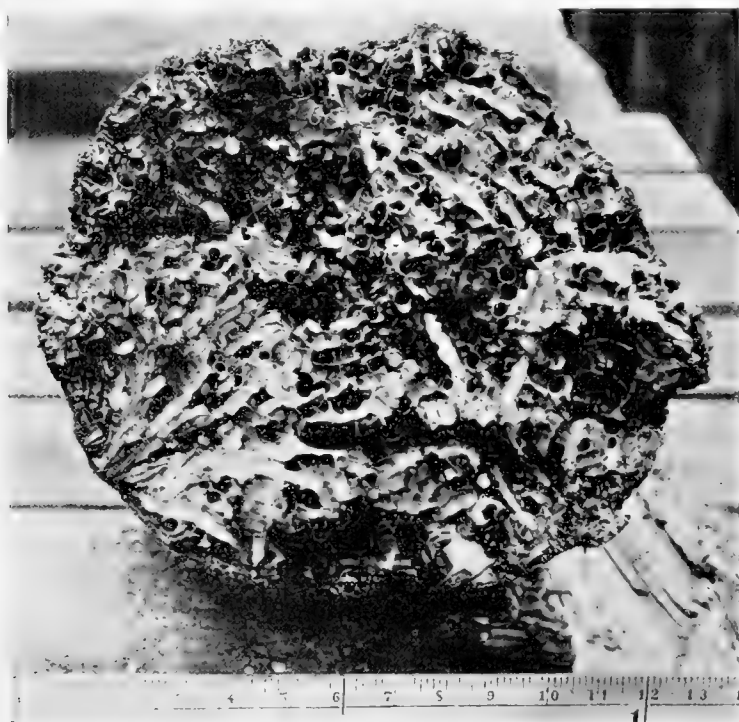
Fig. 89. Breaking point, near mud line, of pile at Oakland Mole, destroyed within 5 months by *Bankia setacea*.

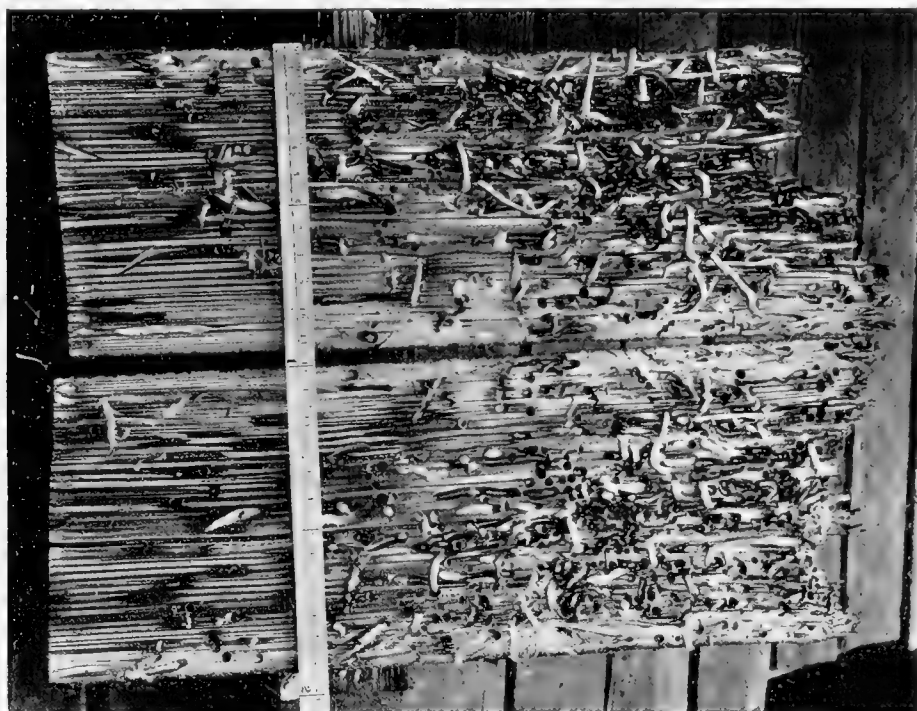
Fig. 90. Split section of pile shown in fig. 89.

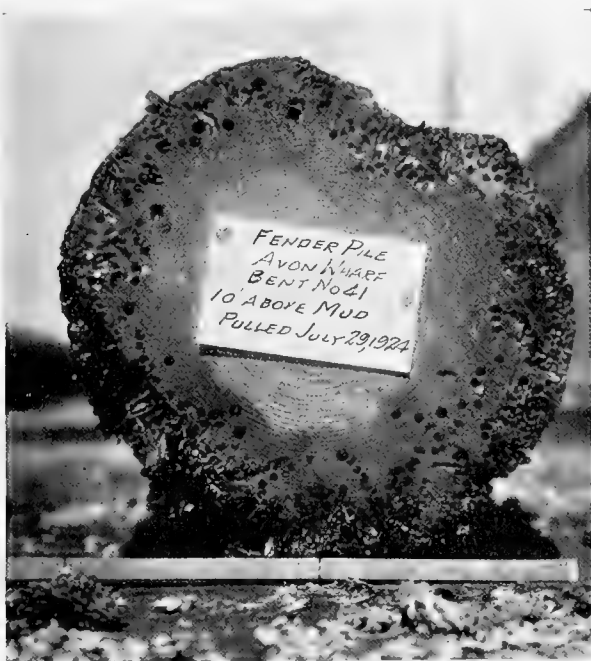
Fig. 96. Section of untreated fender pile from Avon wharf of Associated Oil Co. Pulled July 29, 1924.

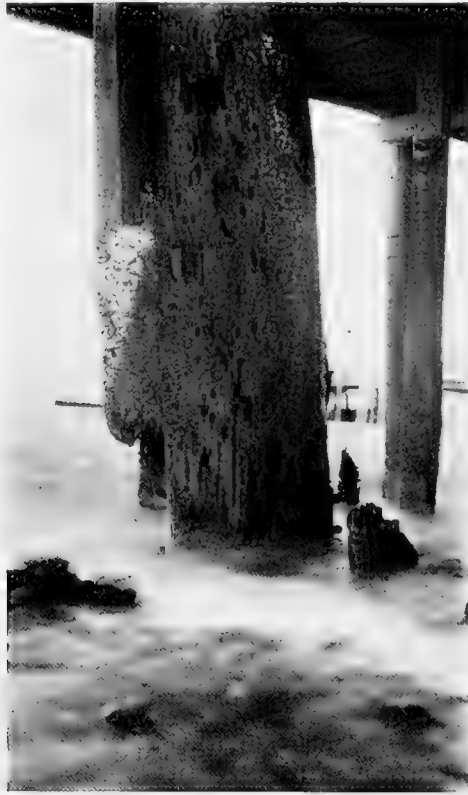
Fig. 139. Pile at China Camp, on the west shore of San Pablo Bay, attacked by *Sphaeroma pentodon* between tide levels.
